Approaches to estimating pathway erosion on the Coast Walk, Royal National Park, New South Wales

Deirdre Dragovich* and Sunil Bajpai

School of Geosciences, University of Sydney, Sydney 2006, Australia

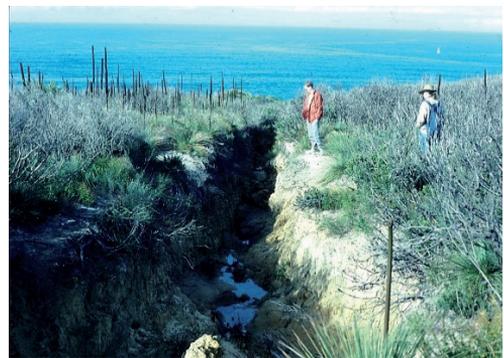
Figure 1: A previously in-filled and subsequently deeply gullied section of the Coast Walk, 1991.

The approximately 30-km long Coast Walk in Royal National Park has long been popular with visitors. It has a history of severe erosion, followed by pathway repair involving infilling of gullies, and subsequent re-erosion of the same sites. In 1981, for example, part of the Walk had been gullied to a depth exceeding 3 m (Young and Young, 2006); and in 1991 a gully more than 2 m deep — later infilled — had led to visitors creating an adjacent informal path (Figure 1). This continuing interaction of erosion processes with visitor impacts and management responses produces changing track conditions over time. Any pathway assessment thus represents conditions at the time of the study, and does not take into account the timeframe over which the observed erosional features developed.

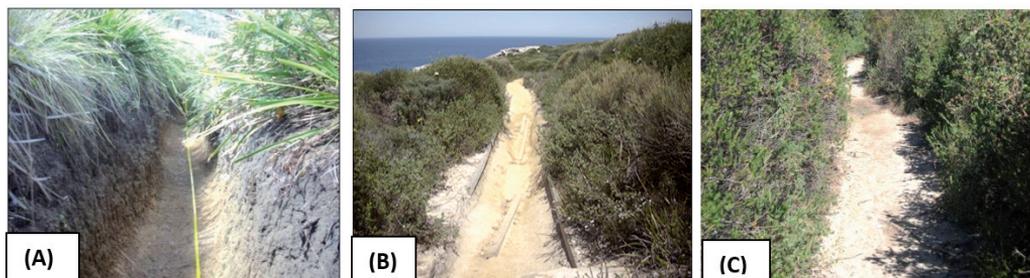
Figure 2: Examples of (A) high, (B) medium and (C) low erosion severity categories.

Erosion severity assessment was based on the three key indicators, of channel (path) depth, surface roughness, and presence of stones, with higher values for measured or observed indicators signifying increased erosion severity. Measured channel depth was the primary indicator applying to all paths while uneven surfaces and stones were not always present. Channel depths were differentiated to broadly reflect the magnitude of water erosion in the form of sheet erosion, rill development and gullying (channels). A threshold channel depth of 30 cm was applied, as this represents the practical difference between rills and gullies (New South Wales Dept. of Primary Industries, 2015).

Rills or shallow channels of ≤ 30 cm in depth were arbitrarily sub-divided into those of < 10 cm (low erosion severity) and of > 10 cm (medium erosion severity), while gullied surfaces were those having channel depths > 30 cm (high erosion severity) (Figure 2). Wind- and water-eroded sandy sections were characterised by pathway hollowing rather than channel development, but the same depth criteria for low, medium and high erosion severity were applied.
